# MANDAN DIESEL FUEL REMEDICATION PROJECT

REGION 8 PRETREATMENT ASSOCIATION ANNUAL CONFERENCE

MAY 2, 2019

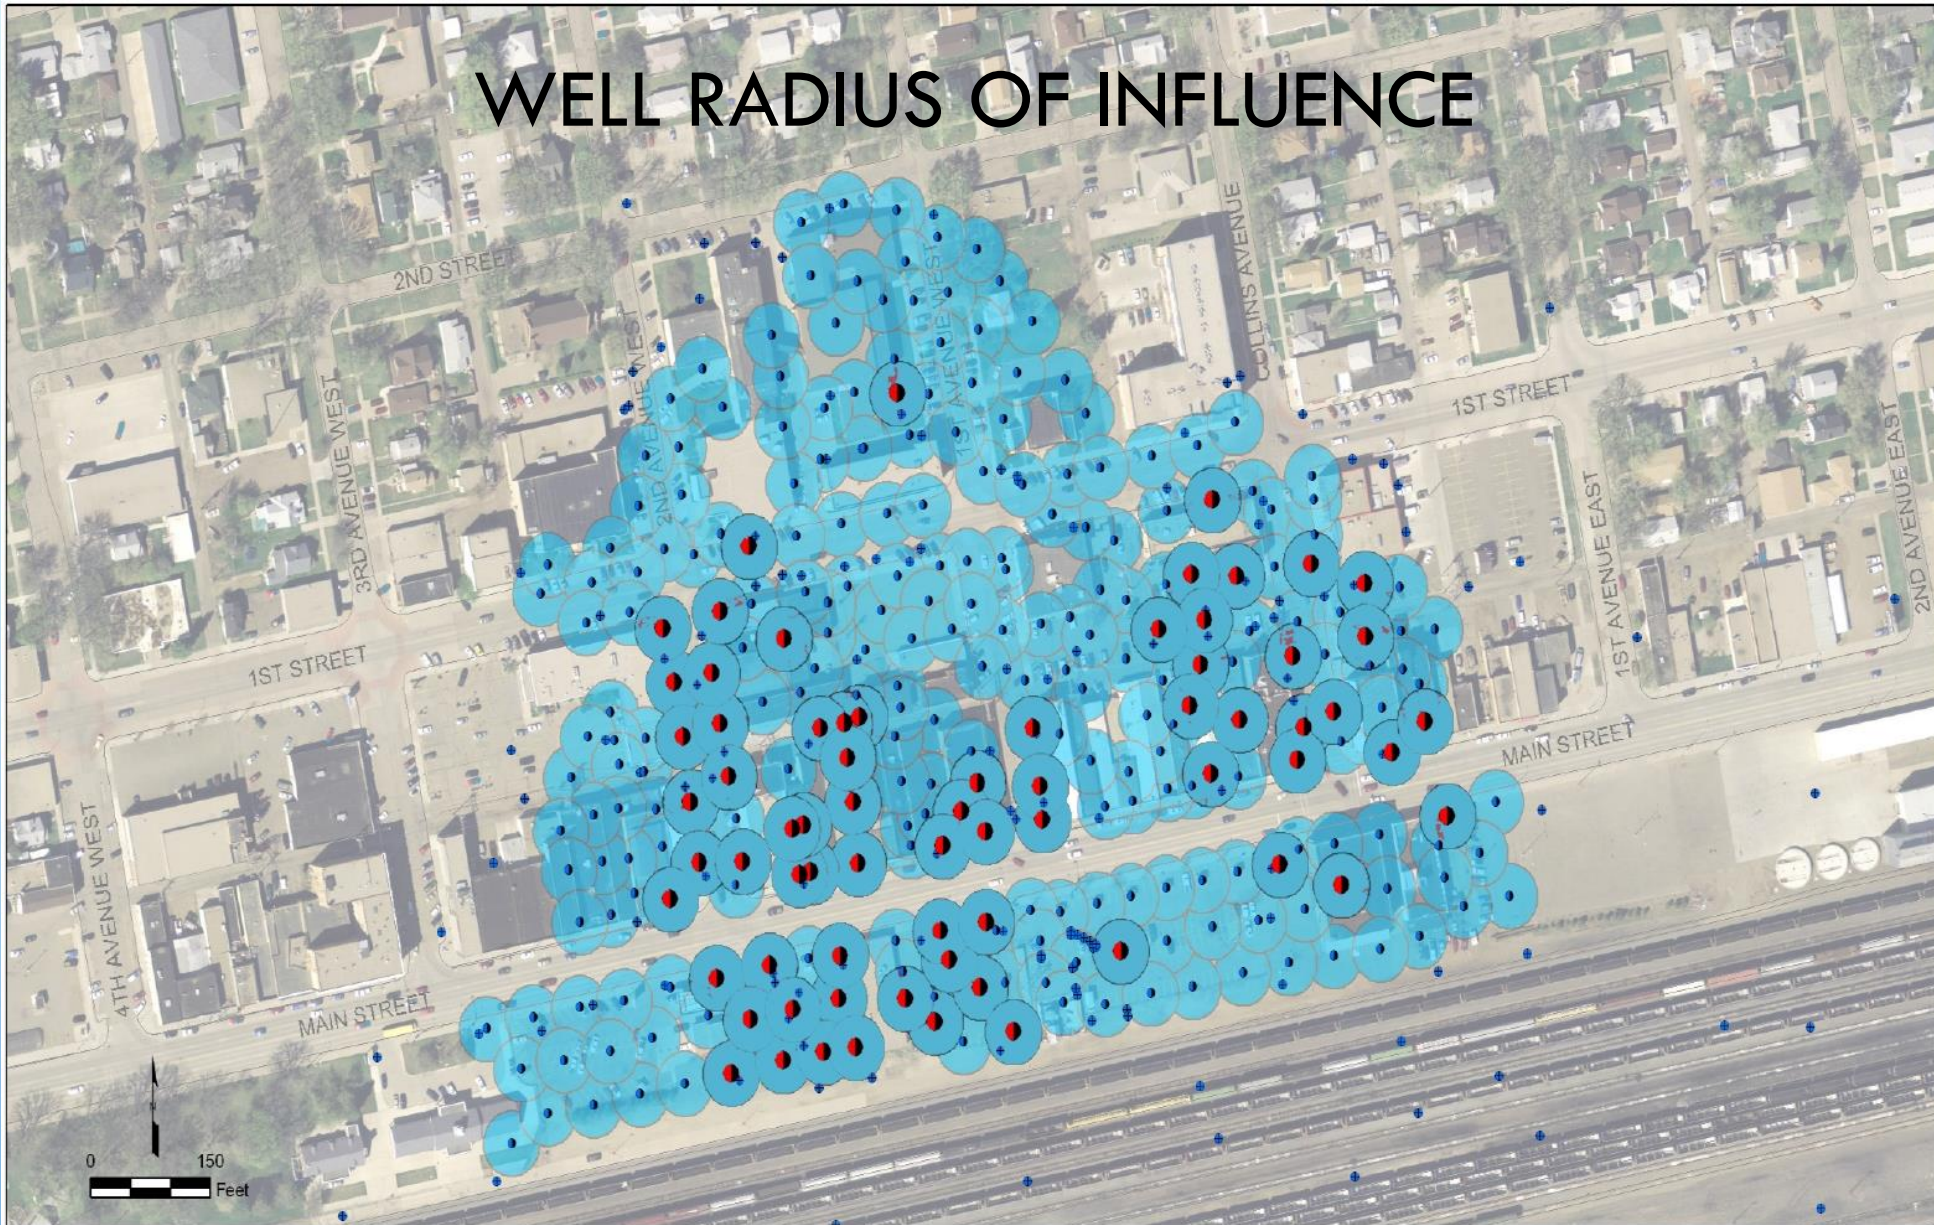
FILE: G3MANDAN07E.MXD	DATE: 12/01/2008	FIGURE: 1
-----------------------	------------------	-----------

# WELL RADIUS OF INFLUENCE

Monitoring / Remedial Well Not in MPE Mode
-

Remedial Well in MPE Mode
-

ROI (35 feet) for Wells in MPE Mode (November 2008)
-

ROI (35 feet) for Wells Not in MPE Mode (November 2008)

REMEDIAL WELLS IN MPE MODE (NOVEMBER 2008)

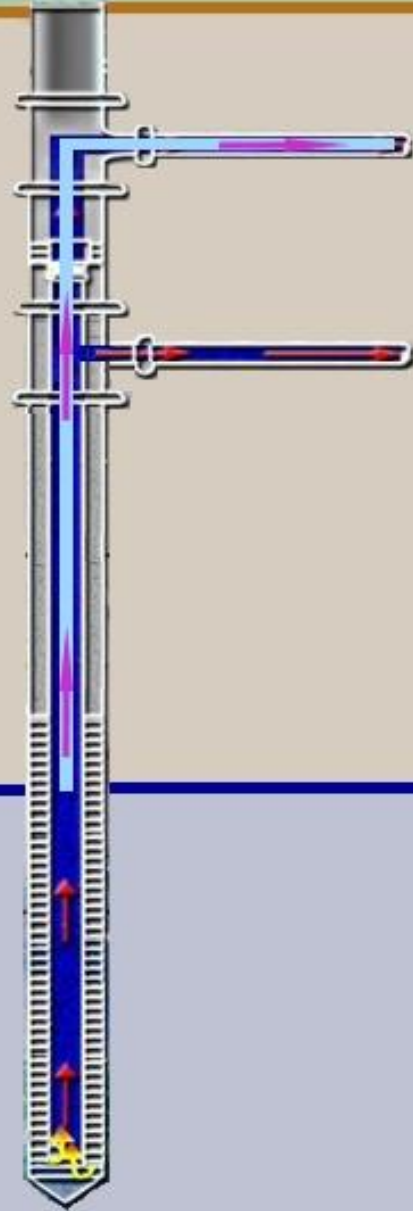
Surface

Multiphase  
Extraction  
(MPE)

Soil Vapor  
Extraction  
(SVE)

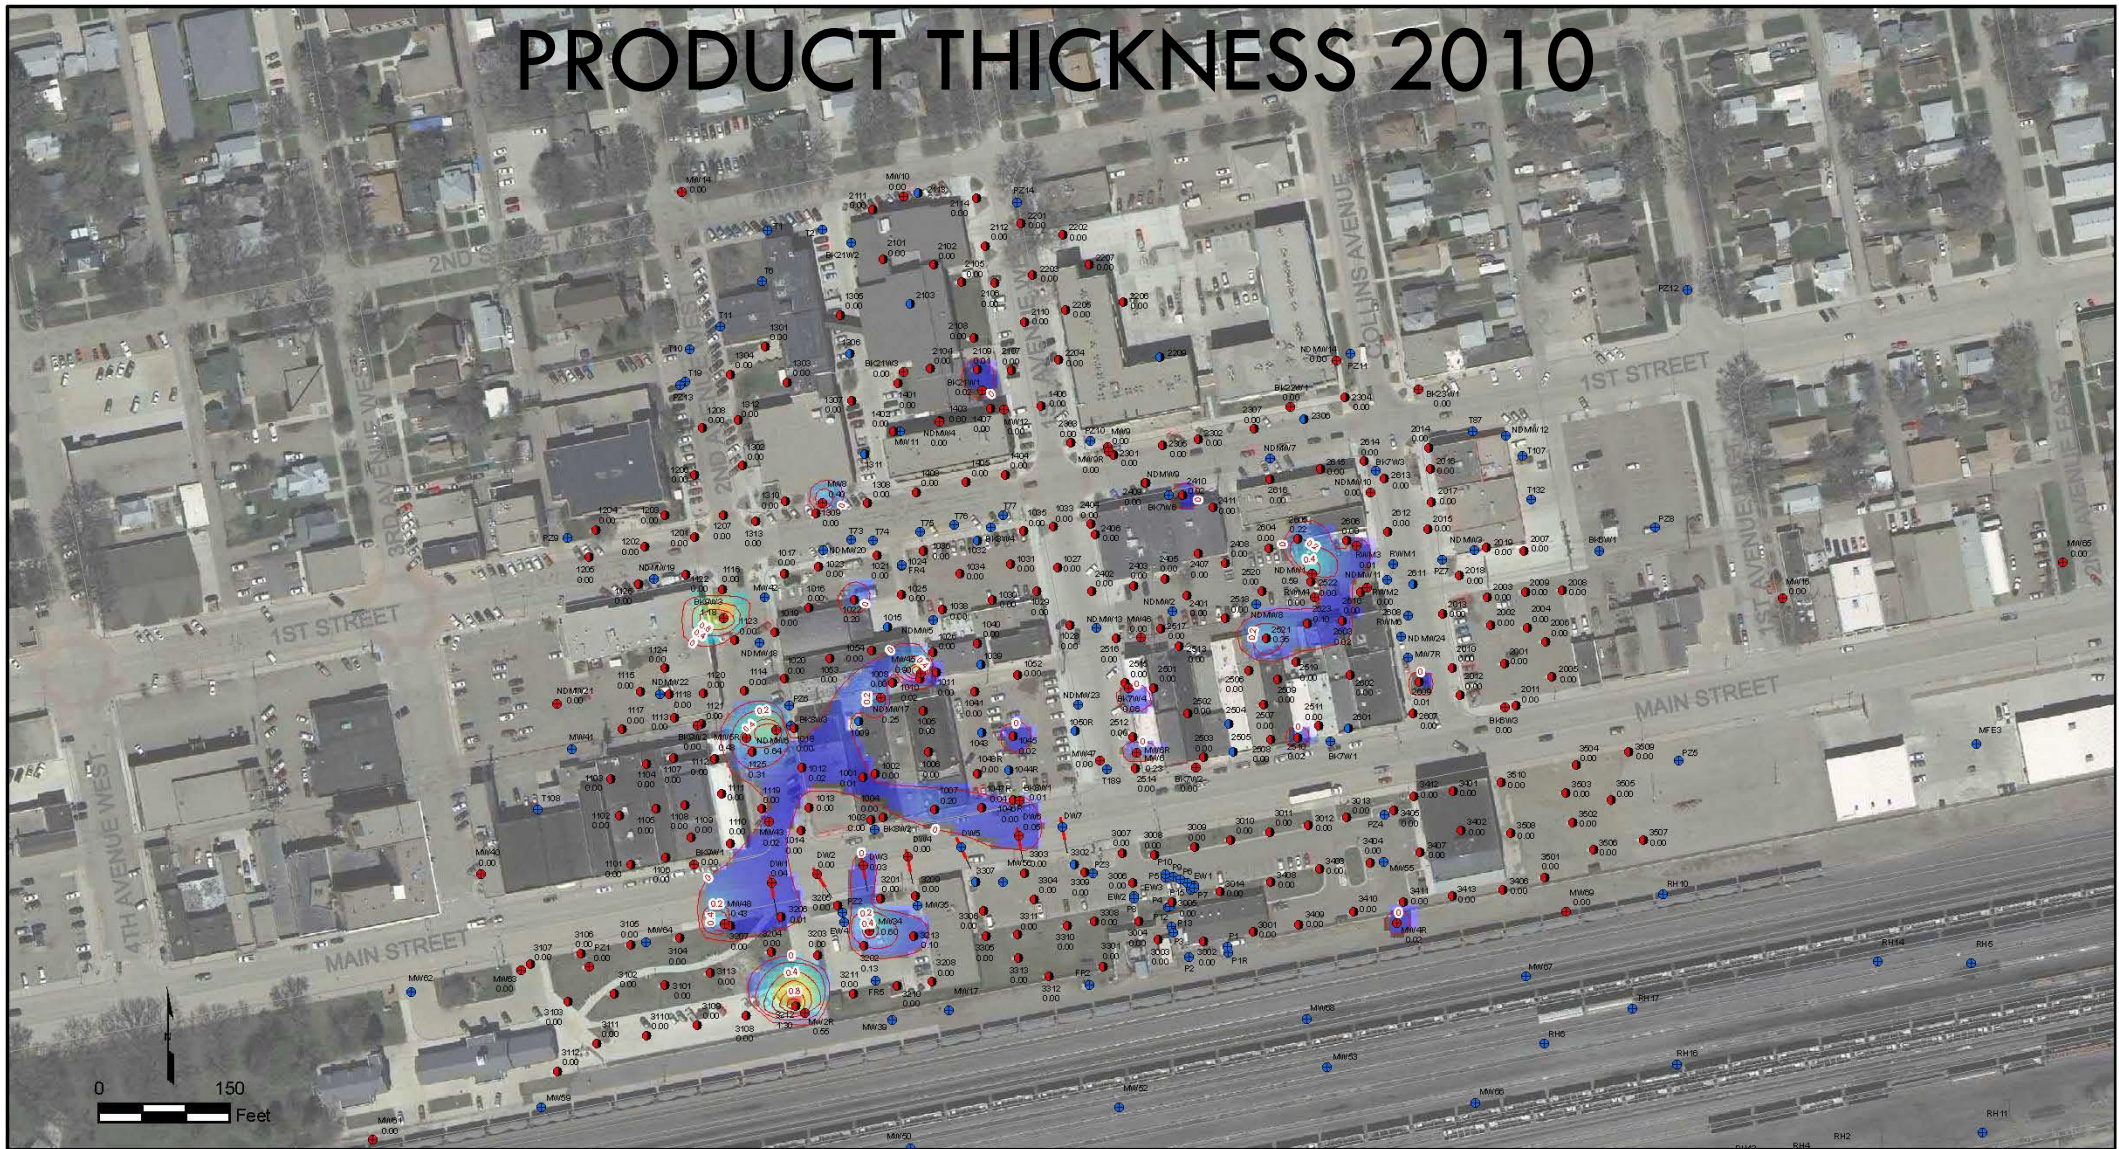
FILE:	G3MANDAN07Z.MXD	DATE:	07/29/2010	FIGURE:	1
-------	-----------------	-------	------------	---------	---

**Product Thickness Contour (feet)**

- / ● Monitoring / Remedial Well Not Measured
- / ● Monitoring / Remedial Well Measured
- 0.48 Product Thickness (feet)

PRODUCT THICKNESS MAY/JUNE 2010
