# PRODUCT THICKNESS 2011

**MANDAN REMEDIATION PROJECT**  
 MANDAN, NORTH DAKOTA

PRODUCT THICKNESS APRIL THROUGH JULY 2011

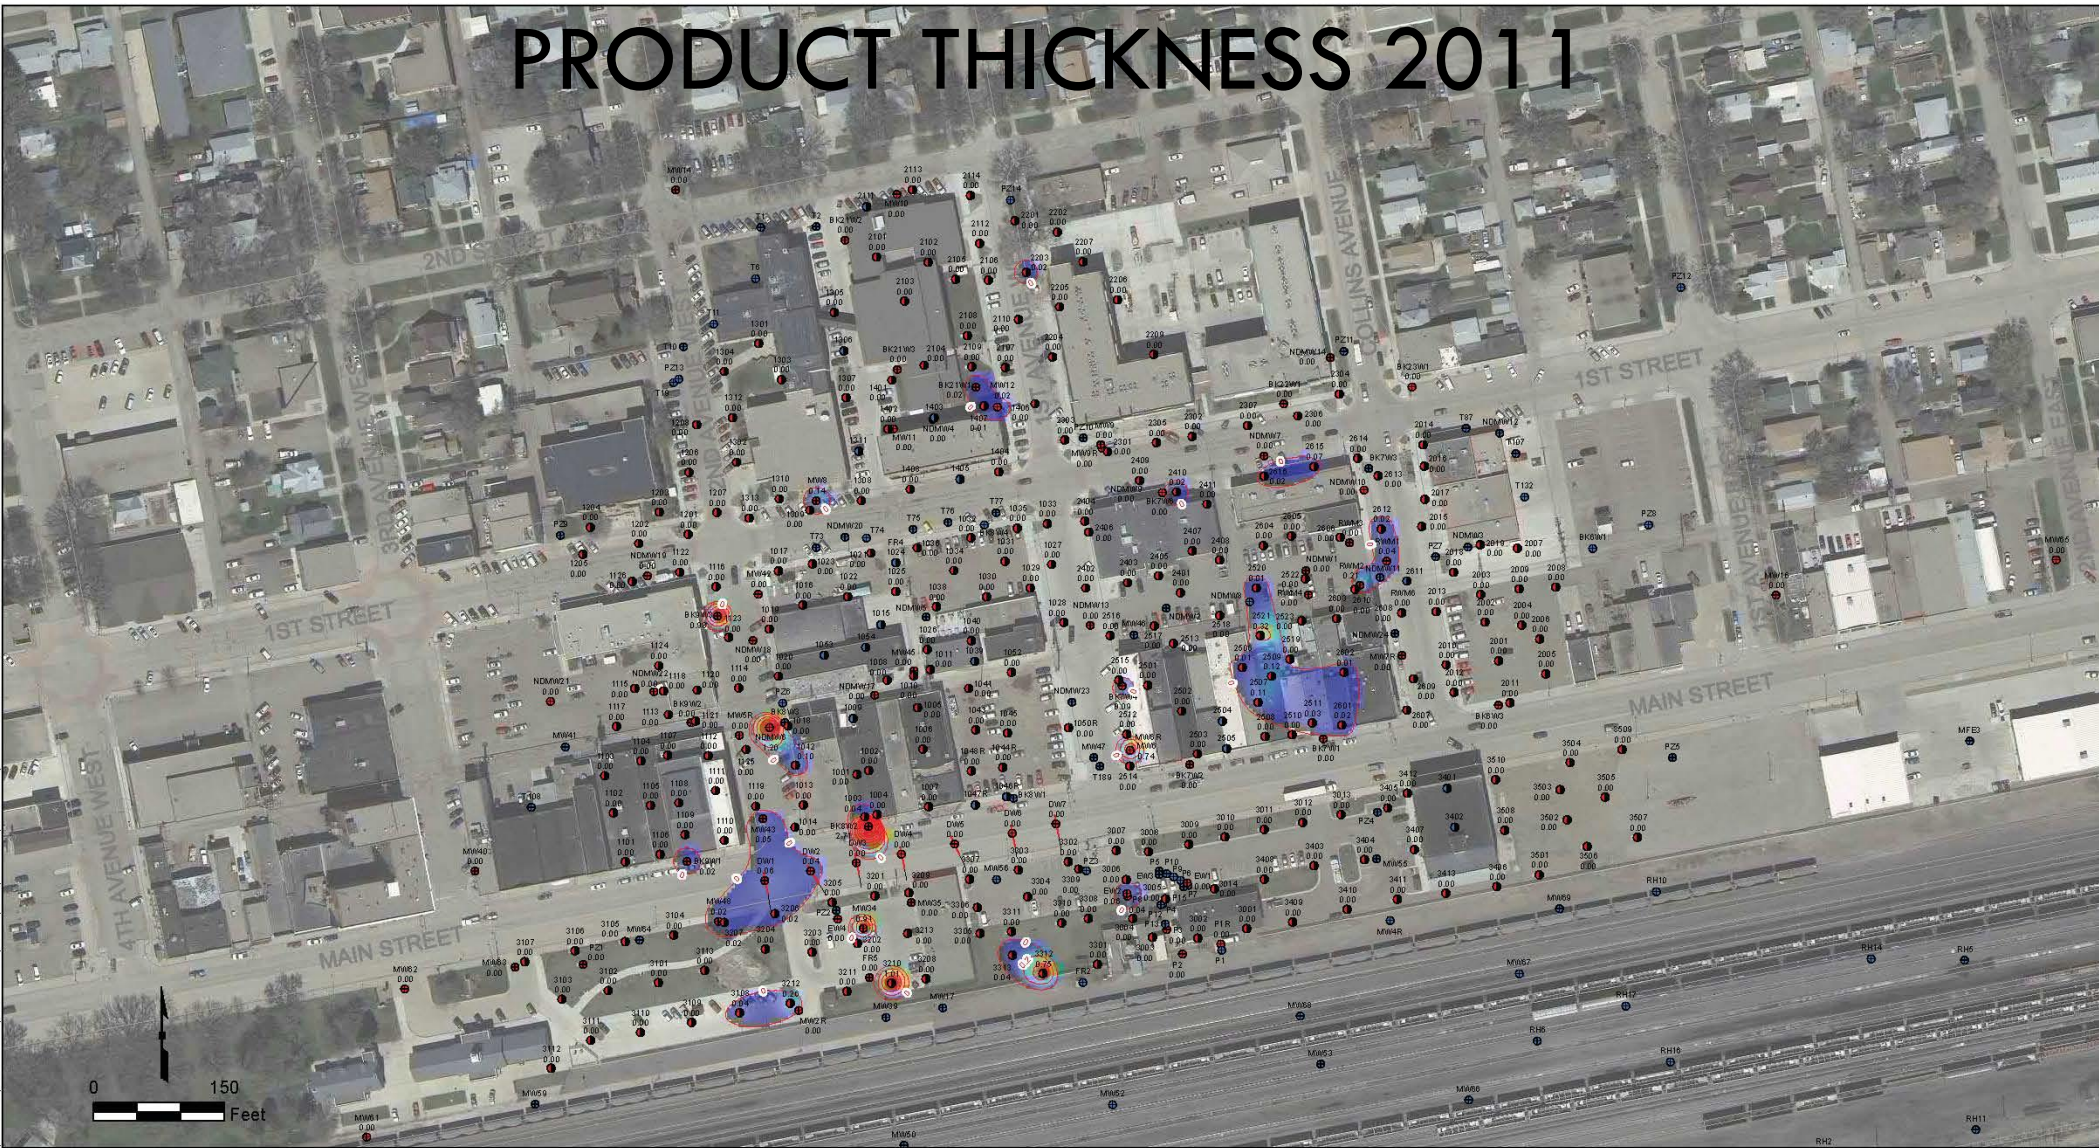
FILE:	G3MANDAN08F.MXD	DATE:	7/22/2011	FIGURE:	1
-------	-----------------	-------	-----------	---------	---

- Product Thickness**
- High: 2.71 feet
  - Low: 0.00 feet
- Product Thickness Contour (feet)**
- Monitoring / Remedial Well Not Measured
  - Monitoring / Remedial Well Measured Product Thickness (feet)

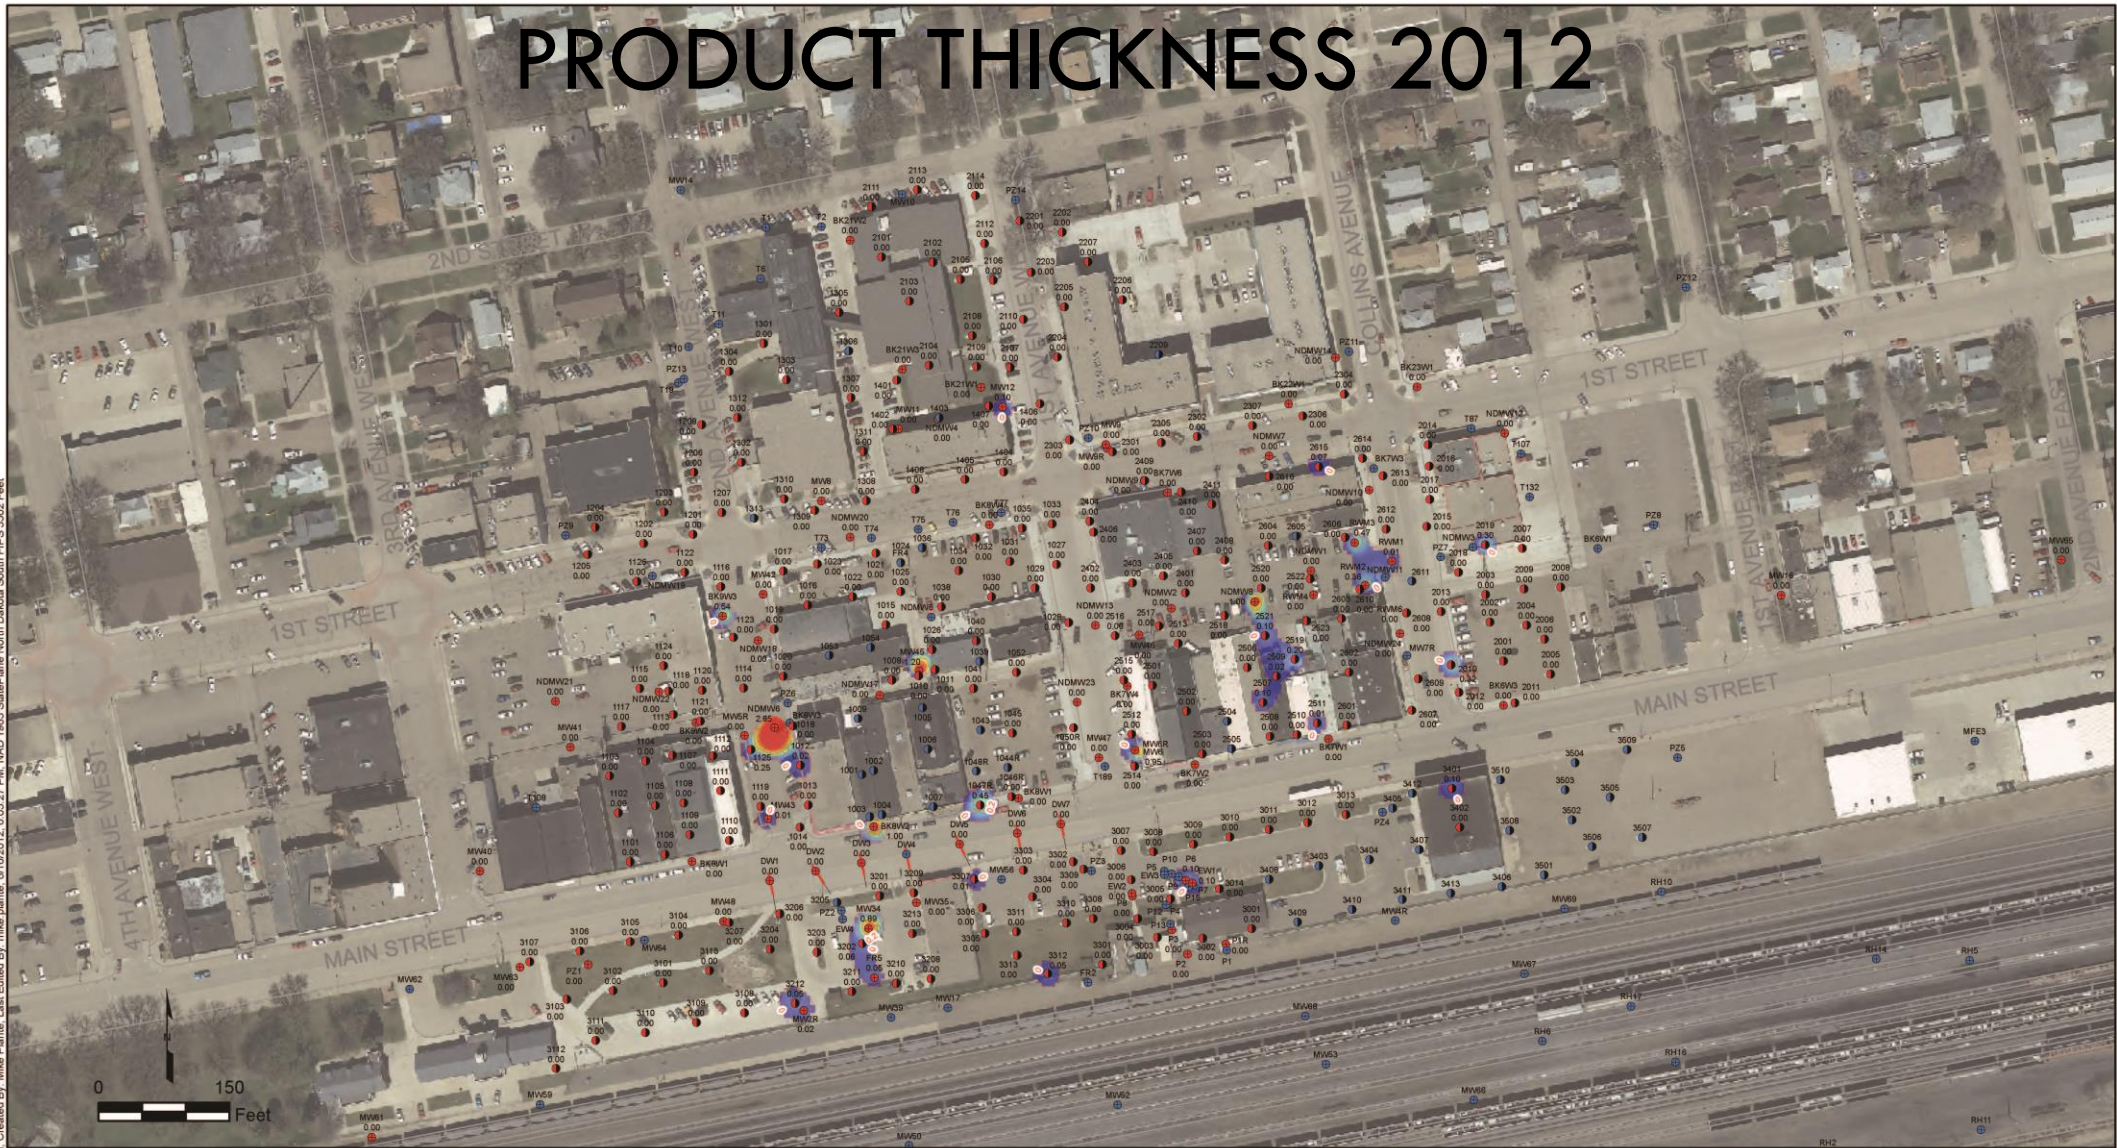
FILE:	G3MANDAN08L.MXD	DATE:	8/16/2012	FIGURE:	1
-------	-----------------	-------	-----------	---------	---

- Product Thickness
- High : 2.85 feet
- Low : 0.00 feet
- Product Thickness Contour (feet)
- Monitoring / Remedial Well Not Measured
- Monitoring / Remedial Well Measured
- 0.05 Product Thickness (feet)

PRODUCT THICKNESS MAY THROUGH JUNE 2012

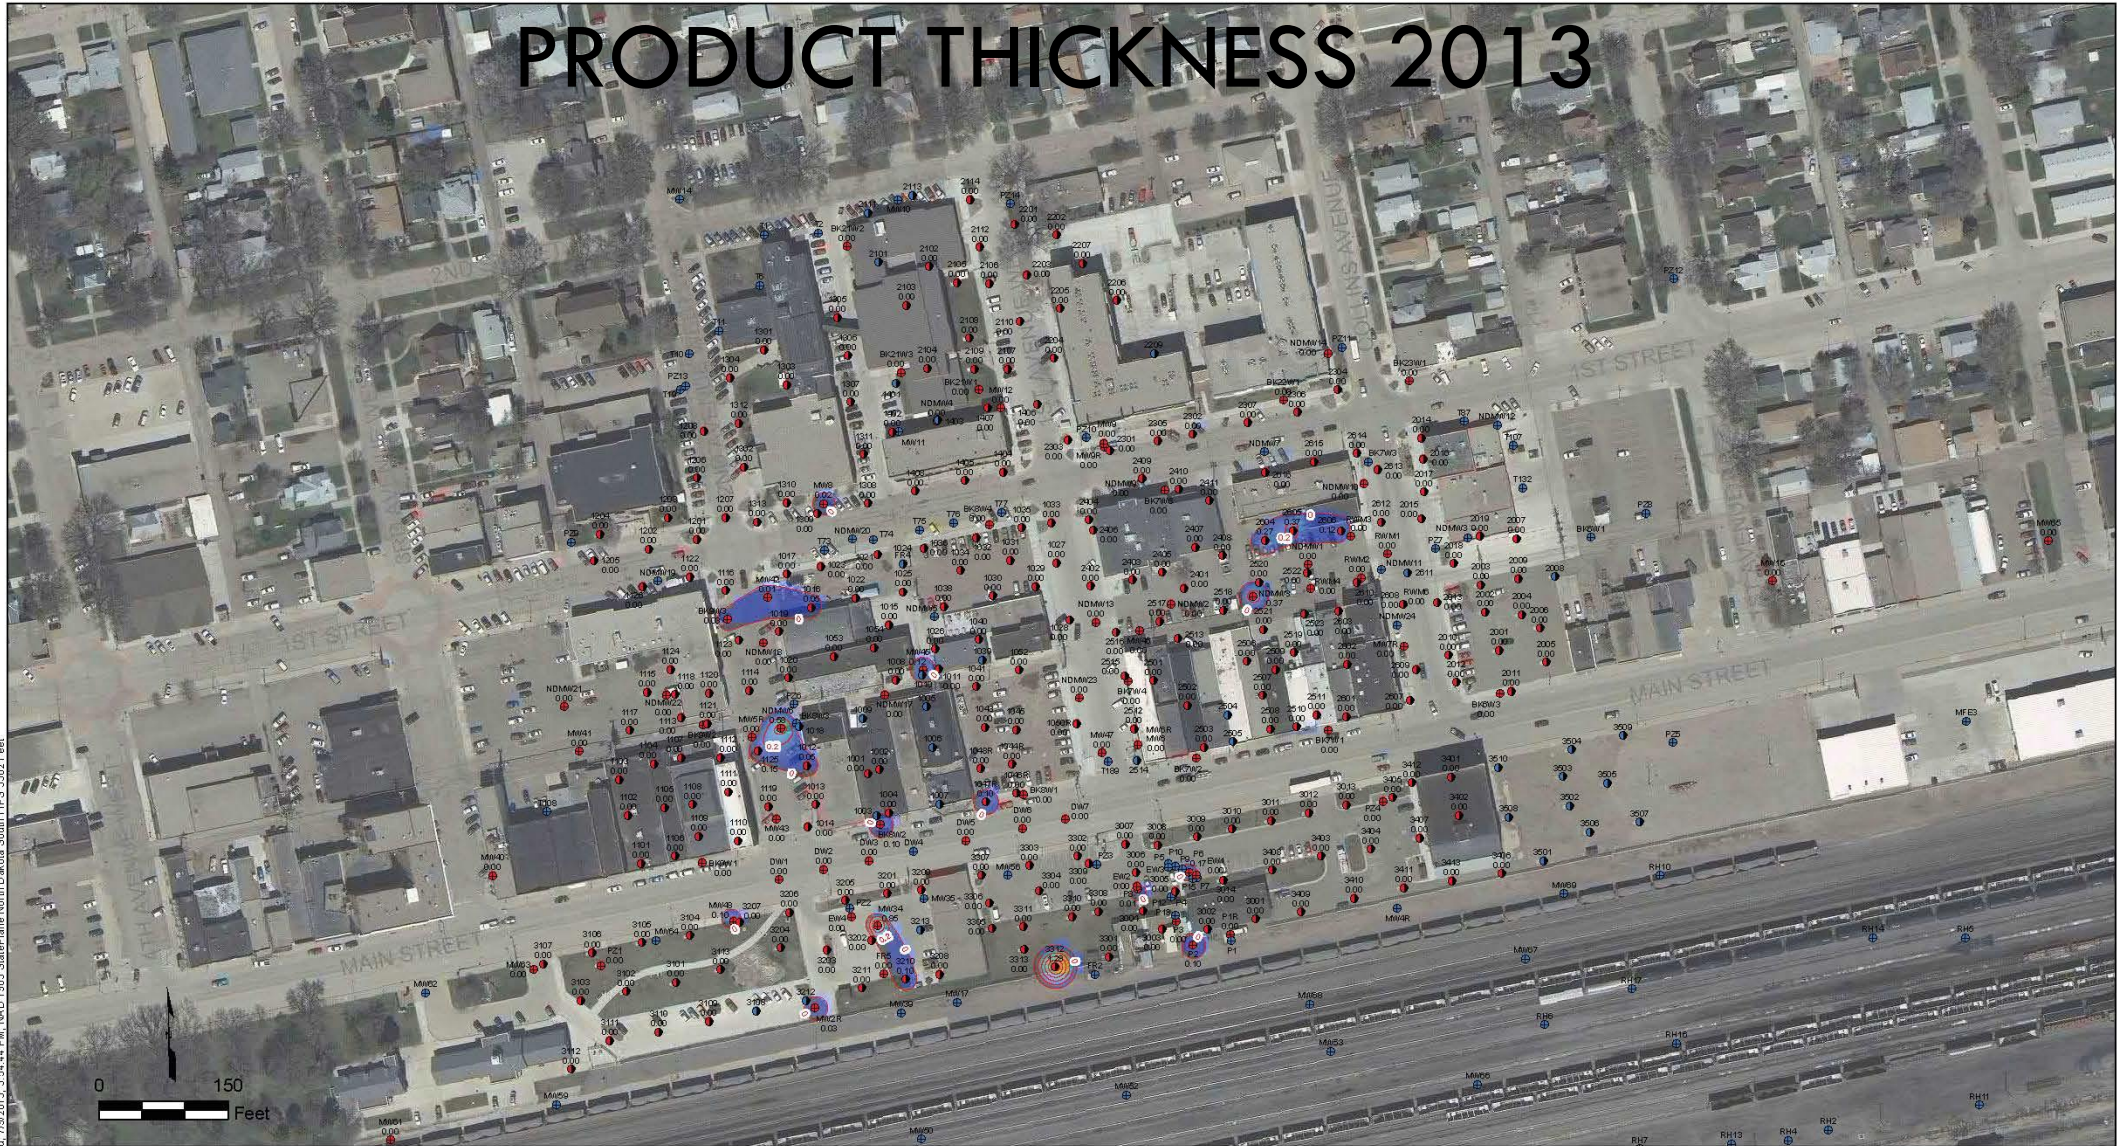
FILE:	G3MANDAN08Q.MXD	DATE:	7/9/2013	FIGURE:	1
-------	-----------------	-------	----------	---------	---

- Product Thickness Contour (feet)
- /● Monitoring / Remedial Well Not Measured
- /● Monitoring / Remedial Well Measured
- 0.03 Product Thickness (feet)

PRODUCT THICKNESS JUNE THROUGH JULY 2013

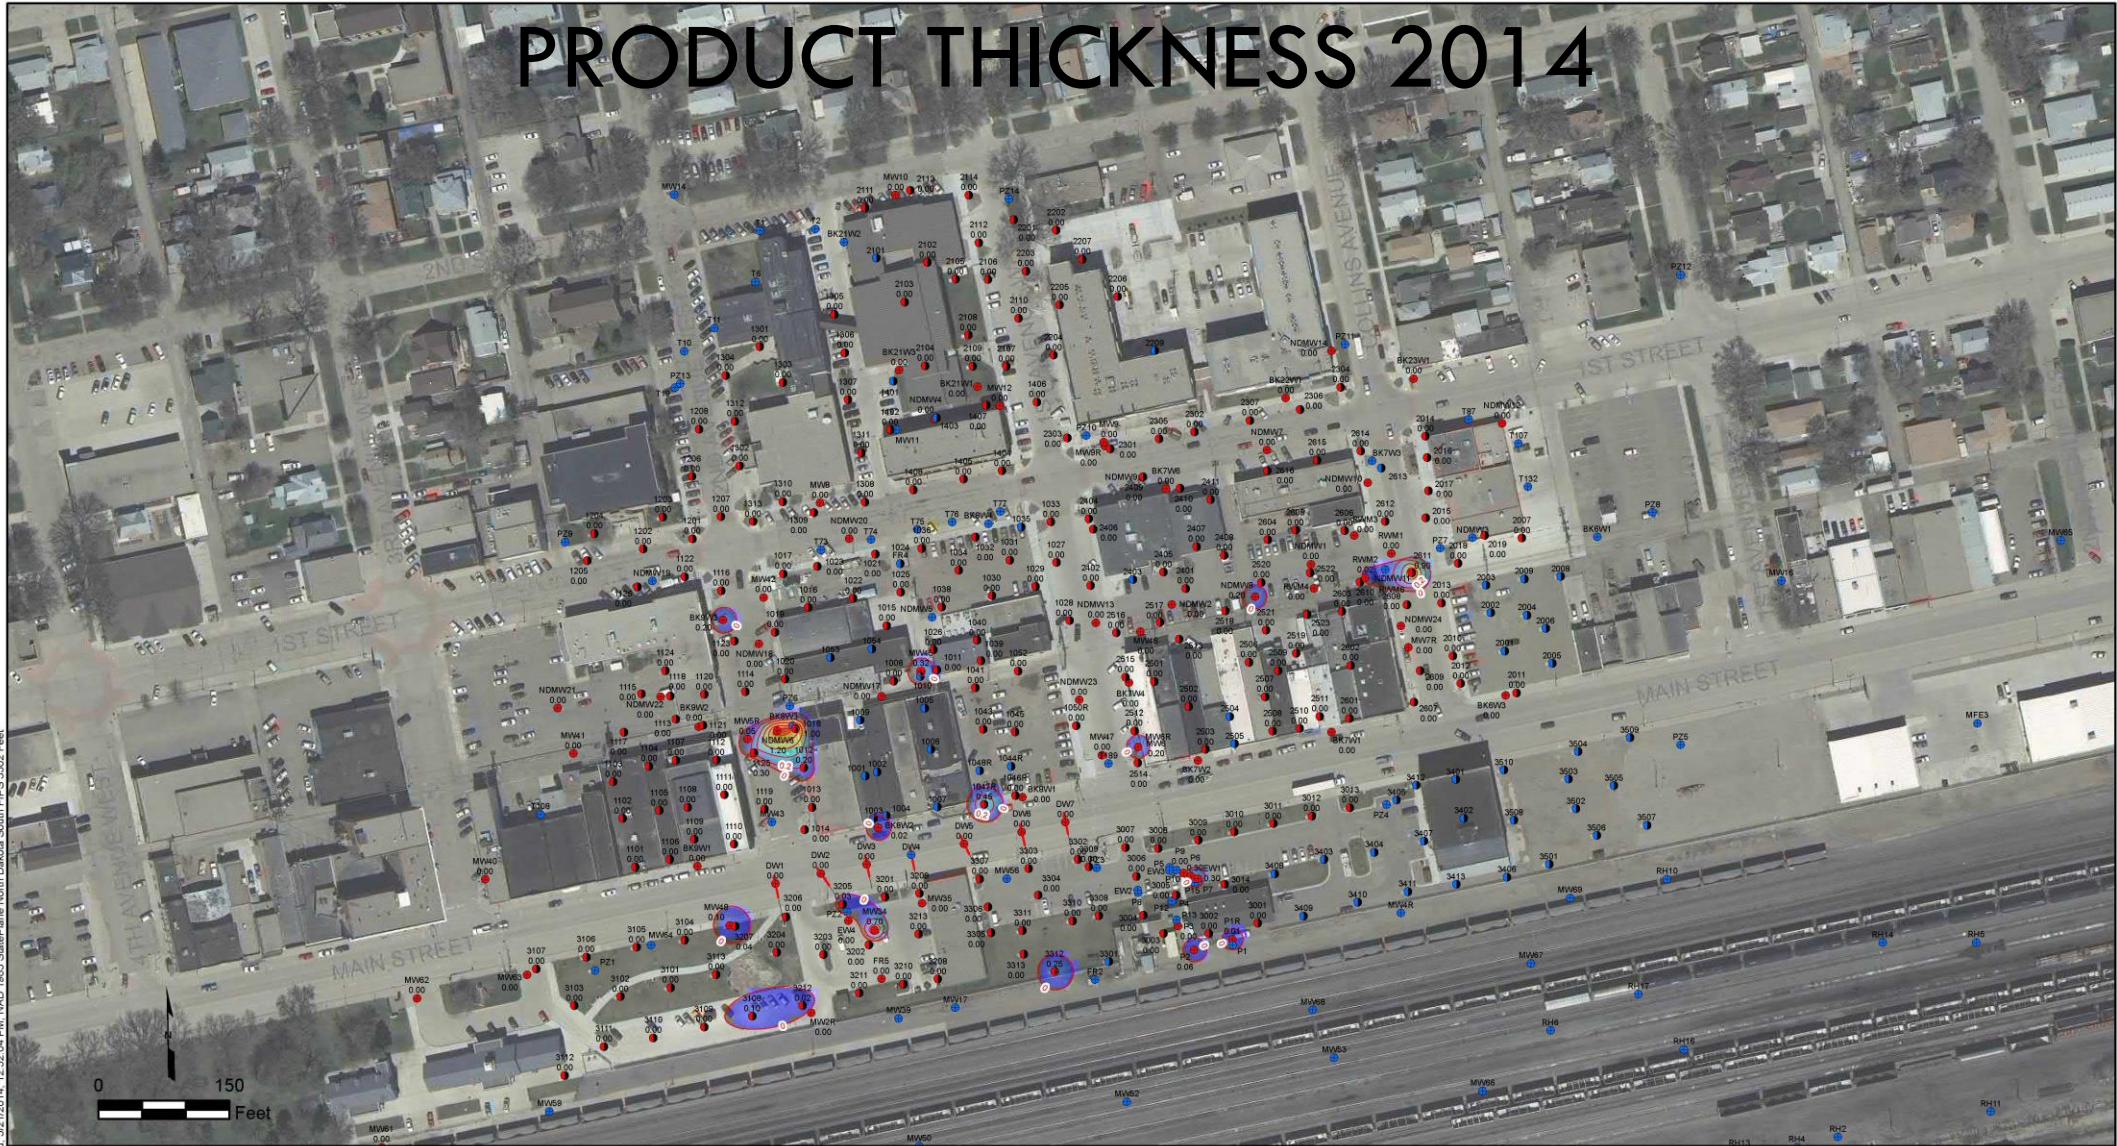
FILE:	G3MANDAN08V.MXD	DATE:	5/21/2014	FIGURE:	1
-------	-----------------	-------	-----------	---------	---

**Product Thickness**  
 High : 1.20 feet  
 Low : 0.00 feet

**Product Thickness Contour (feet)**  
 Monitoring / Remedial Well Not Measured  
 0.05 Product Thickness (feet)

**PRODUCT THICKNESS APRIL THROUGH MAY 2014**

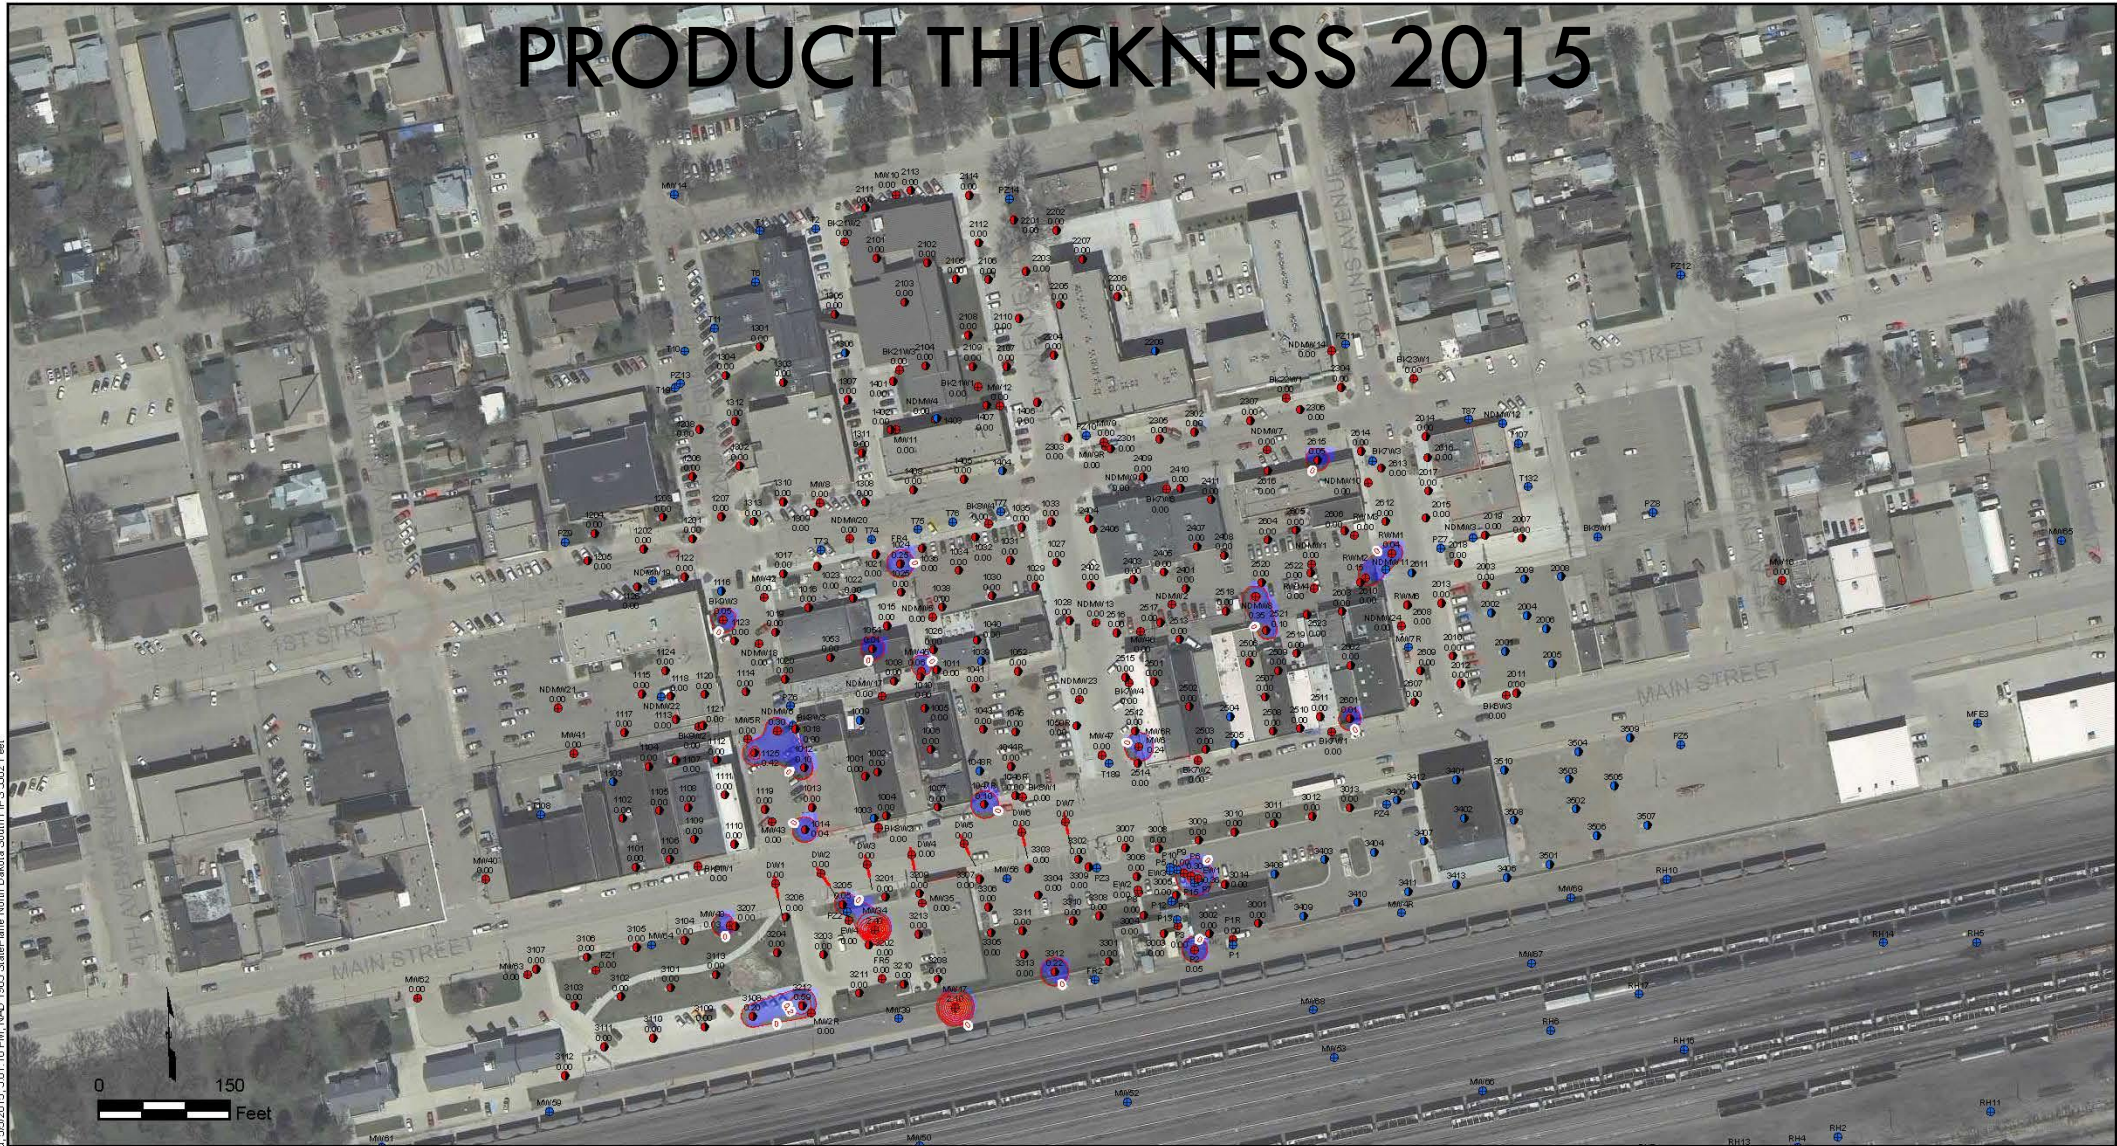
FILE: G3MANDAN08Y.MXD DATE: 5/5/2015 FIGURE: 1

**Product Thickness**  
 High : 2.40 feet  
 Low : 0.00 feet

**Product Thickness Contour (feet)**  
 ●/● Monitoring / Remedial Well Not Measured  
 ●/● Monitoring / Remedial Well Measured  
 0.59 Product Thickness (feet)

PRODUCT THICKNESS MARCH AND APRIL 2015

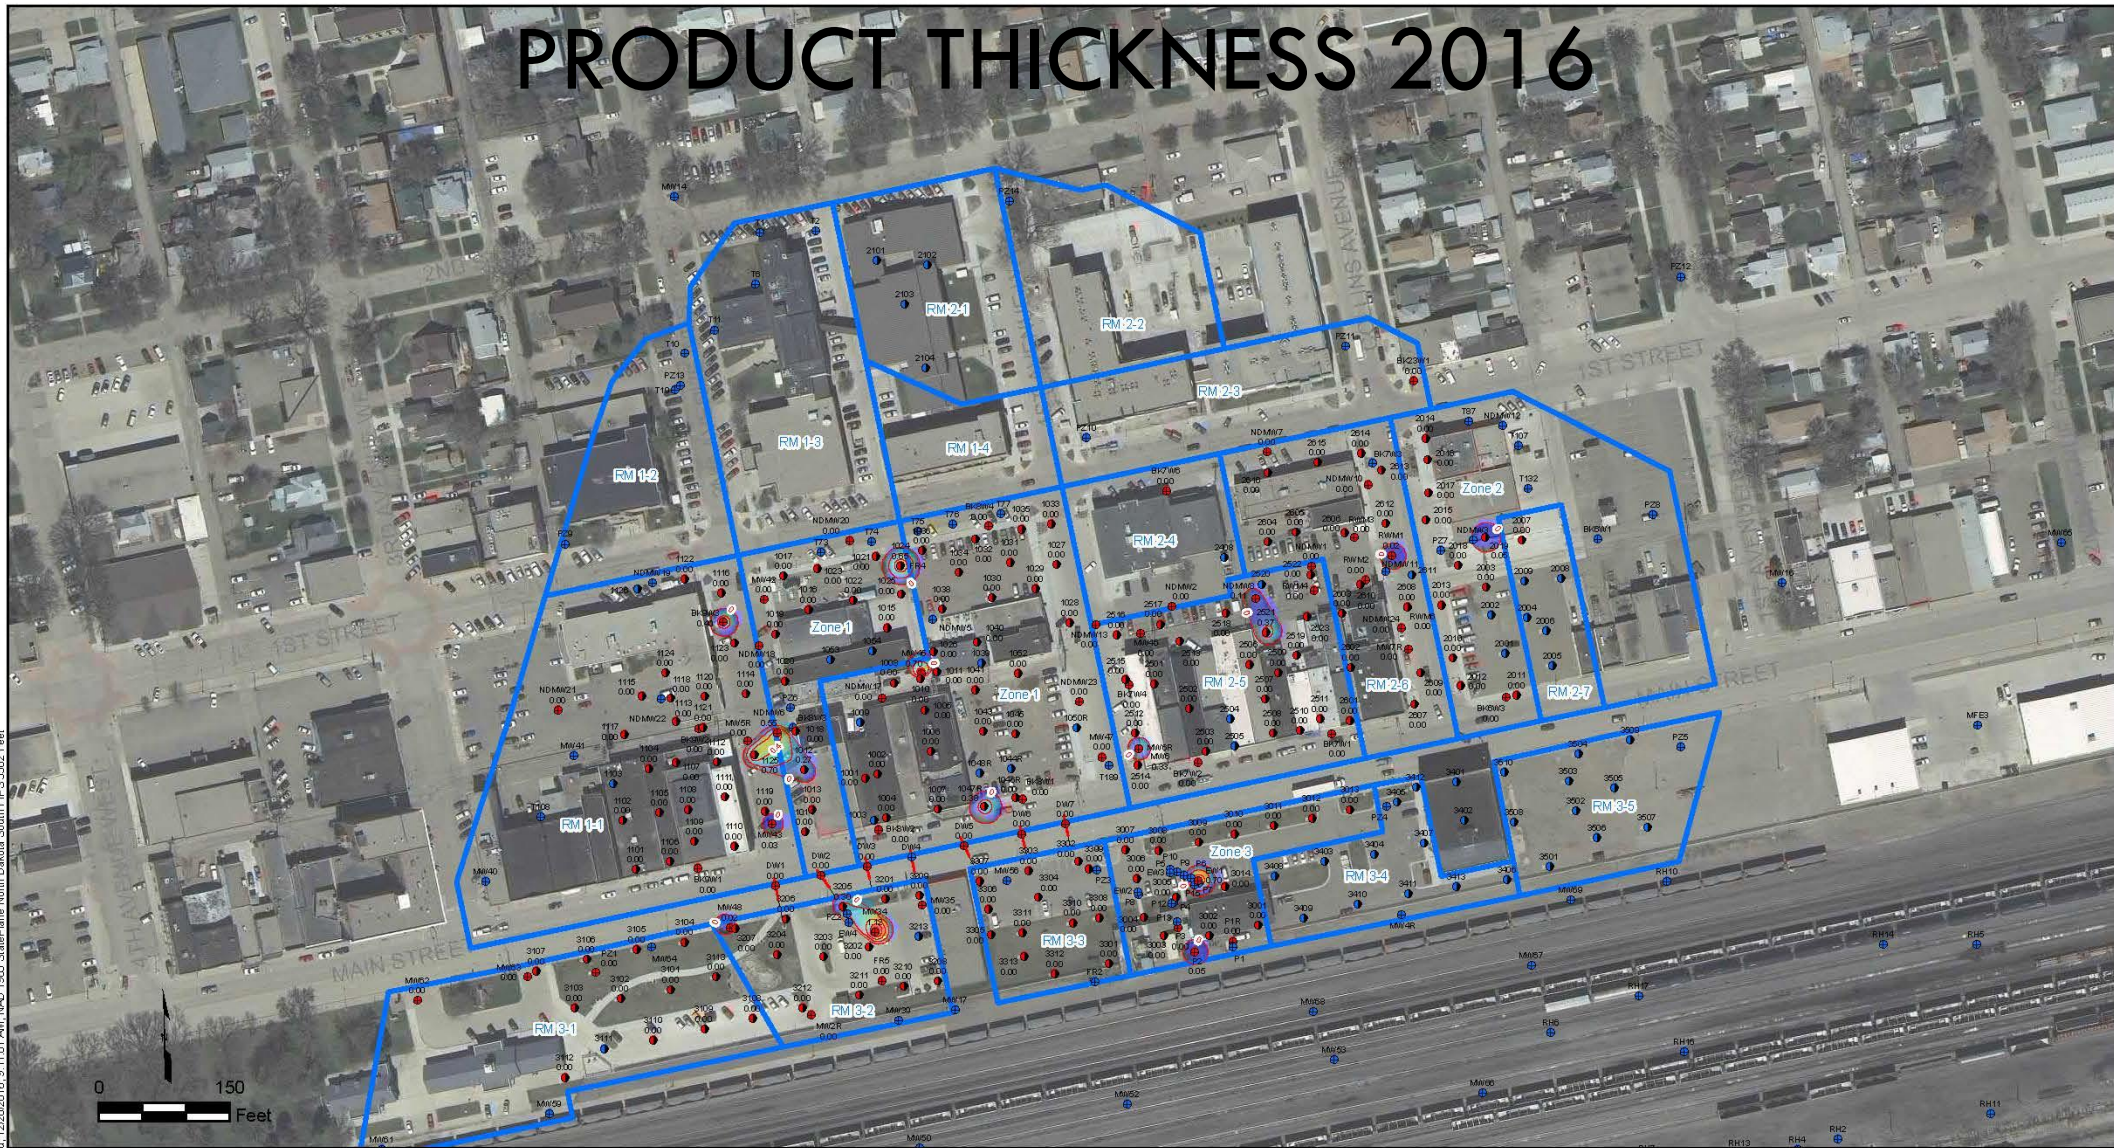
FILE:	G3MANDAN09B.MXD	DATE:	12/20/2016	FIGURE:	1
-------	-----------------	-------	------------	---------	---

- Product Thickness
- Product Thickness Contour (feet)
- Monitoring / Remedial Well Not Measured
- Monitoring / Remedial Well Measured
- 1.12 Product Thickness (feet)
- Remote Manifold Boundary

PRODUCT THICKNESS APRIL AND MAY 2016

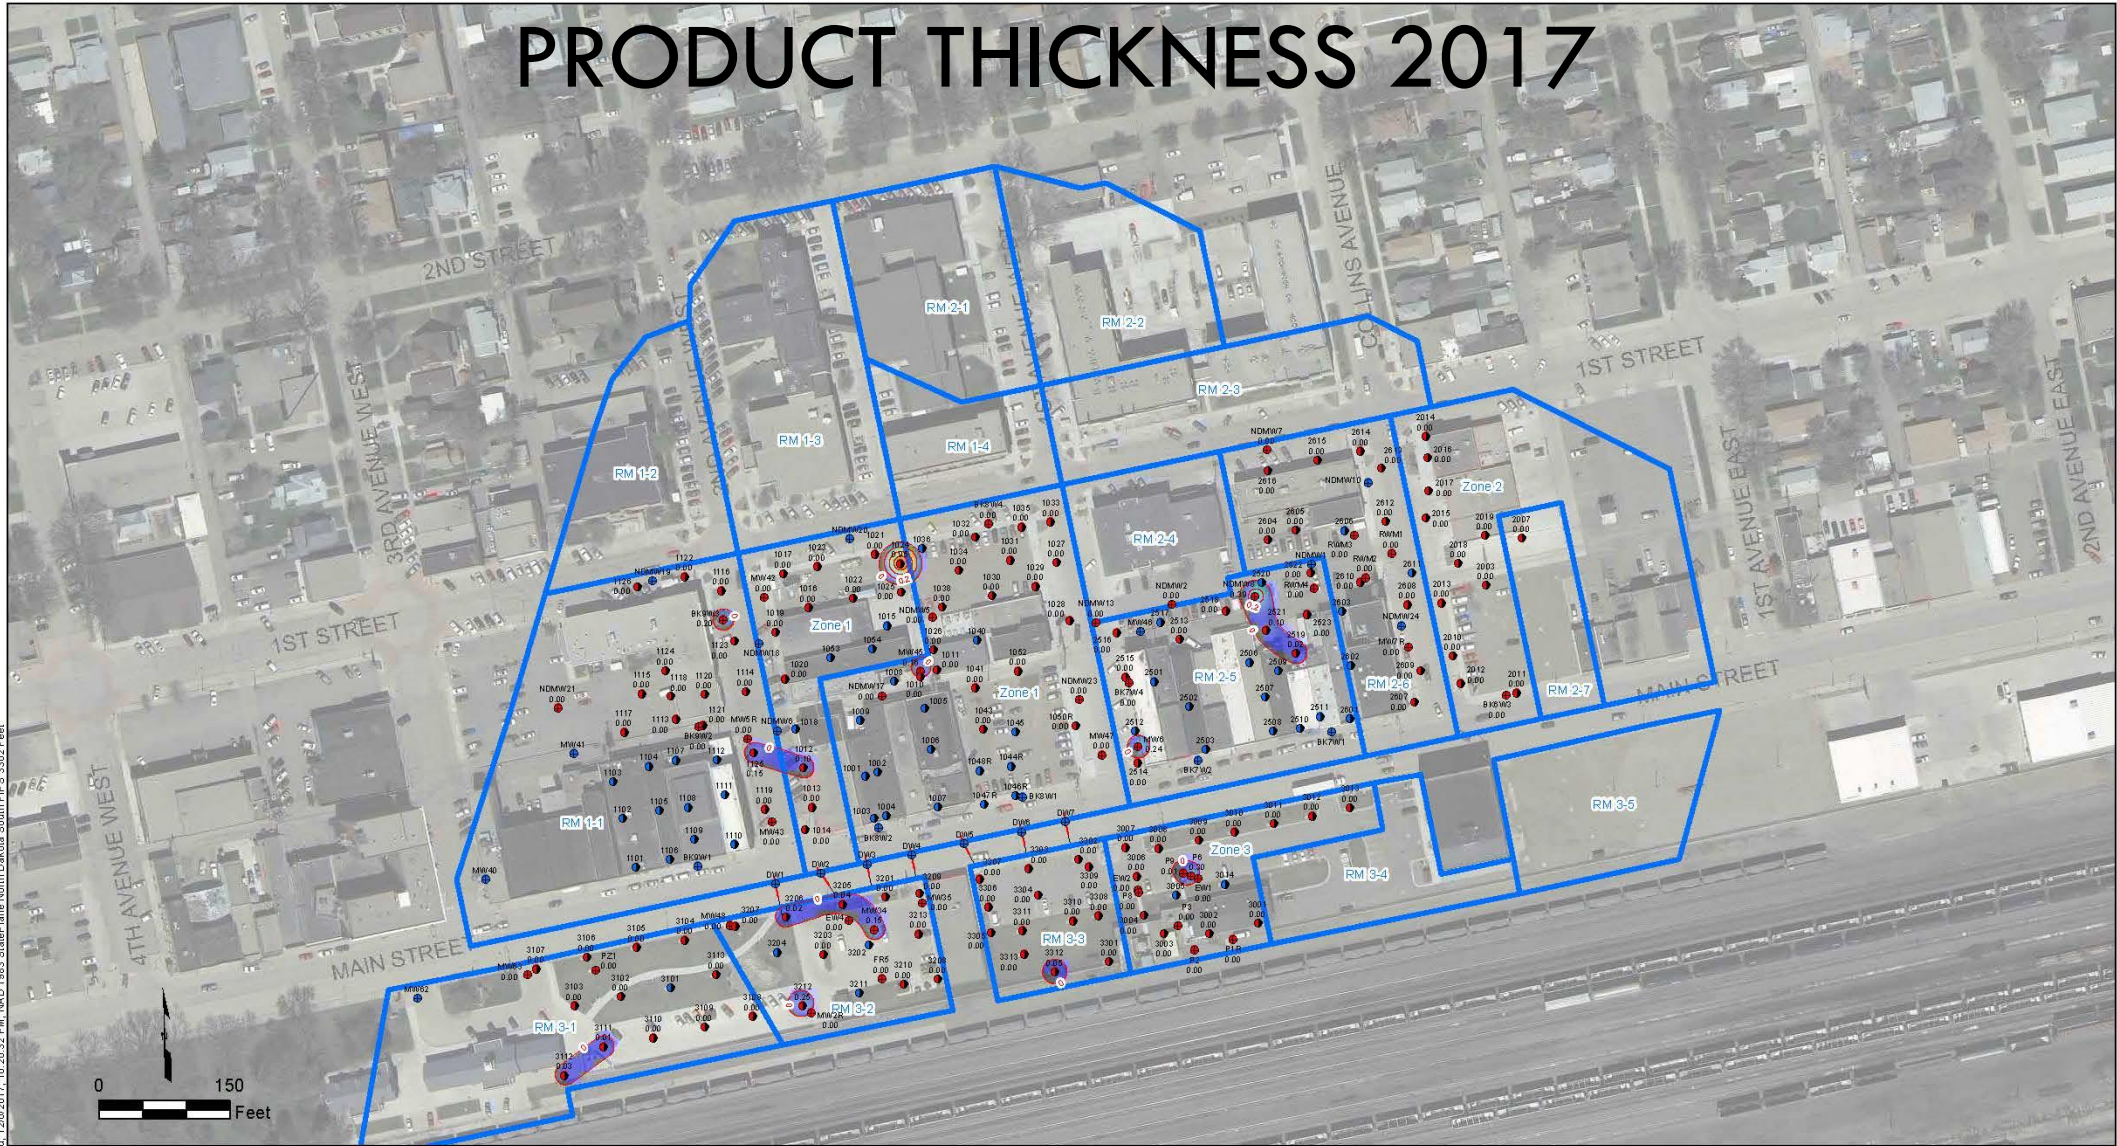
FILE:	G3MANDAN09E.MXD	DATE:	12/6/2017	FIGURE:	1
-------	-----------------	-------	-----------	---------	---

- Product Thickness Contour (feet)
- / ● Monitoring / Remedial Well Not Measured
- / ● Monitoring / Remedial Well Measured
- 0.95 Product Thickness (feet)
- Remote Manifold Boundary

PRODUCT THICKNESS SEPTEMBER TO OCTOBER 2017

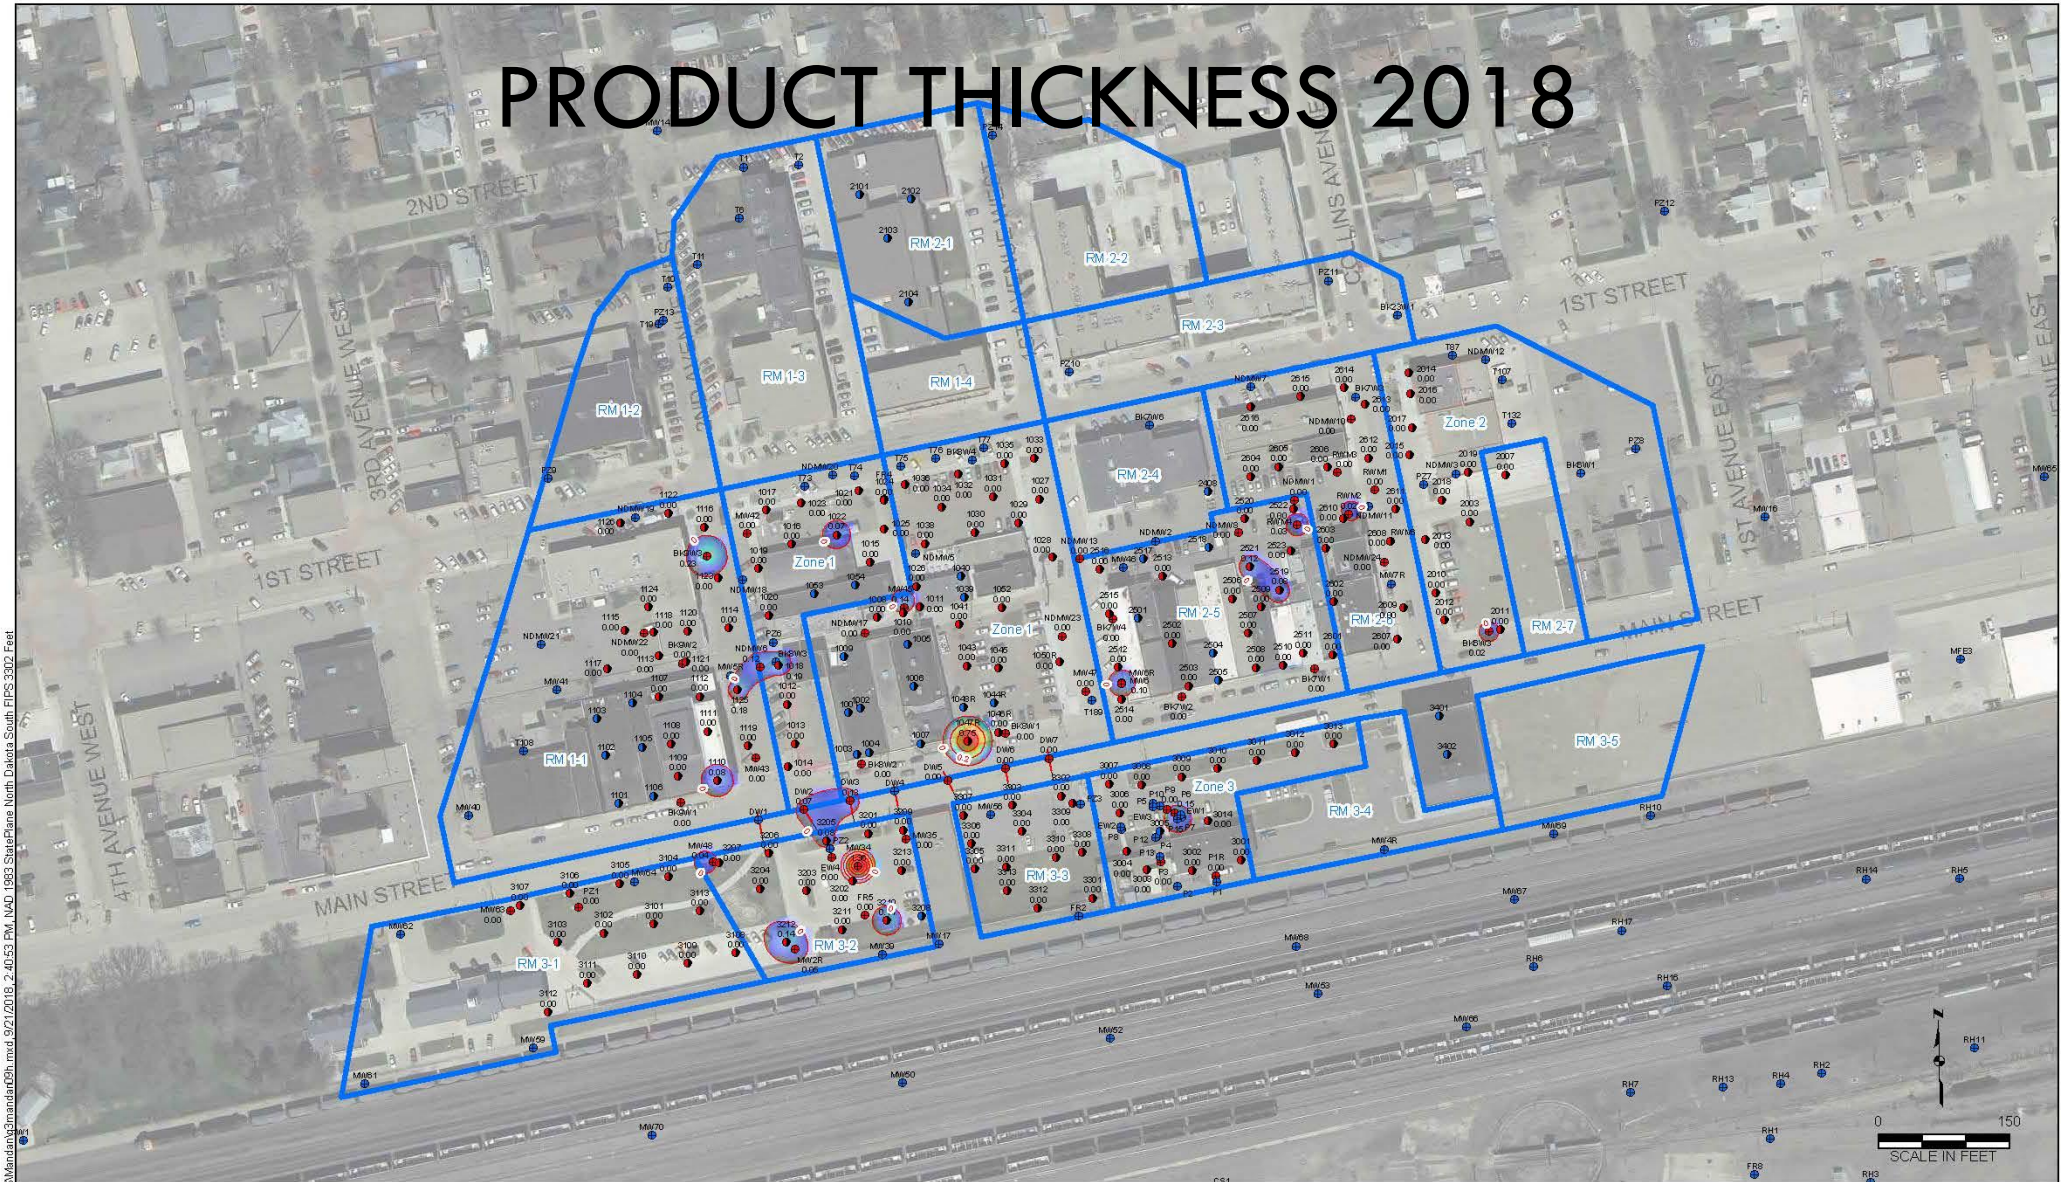
**FIGURE 1**

- Product Thickness
  - High : 1.36 feet
  - Low : 0.00 feet
- Product Thickness Contour (feet)
  - Monitoring / Remedial Well Not Measured
  - Monitoring / Remedial Well Measured
  - 0.05 Product Thickness (feet)
  - Remote Manifold Boundary

Drawn: 9/21/2018  
 Service Layer Credits: Cross Section B-B' from LBG's 2016 Desktop Hydrogeologic Assessment.

**PRODUCT THICKNESS AUGUST-SEPTEMBER 2018**

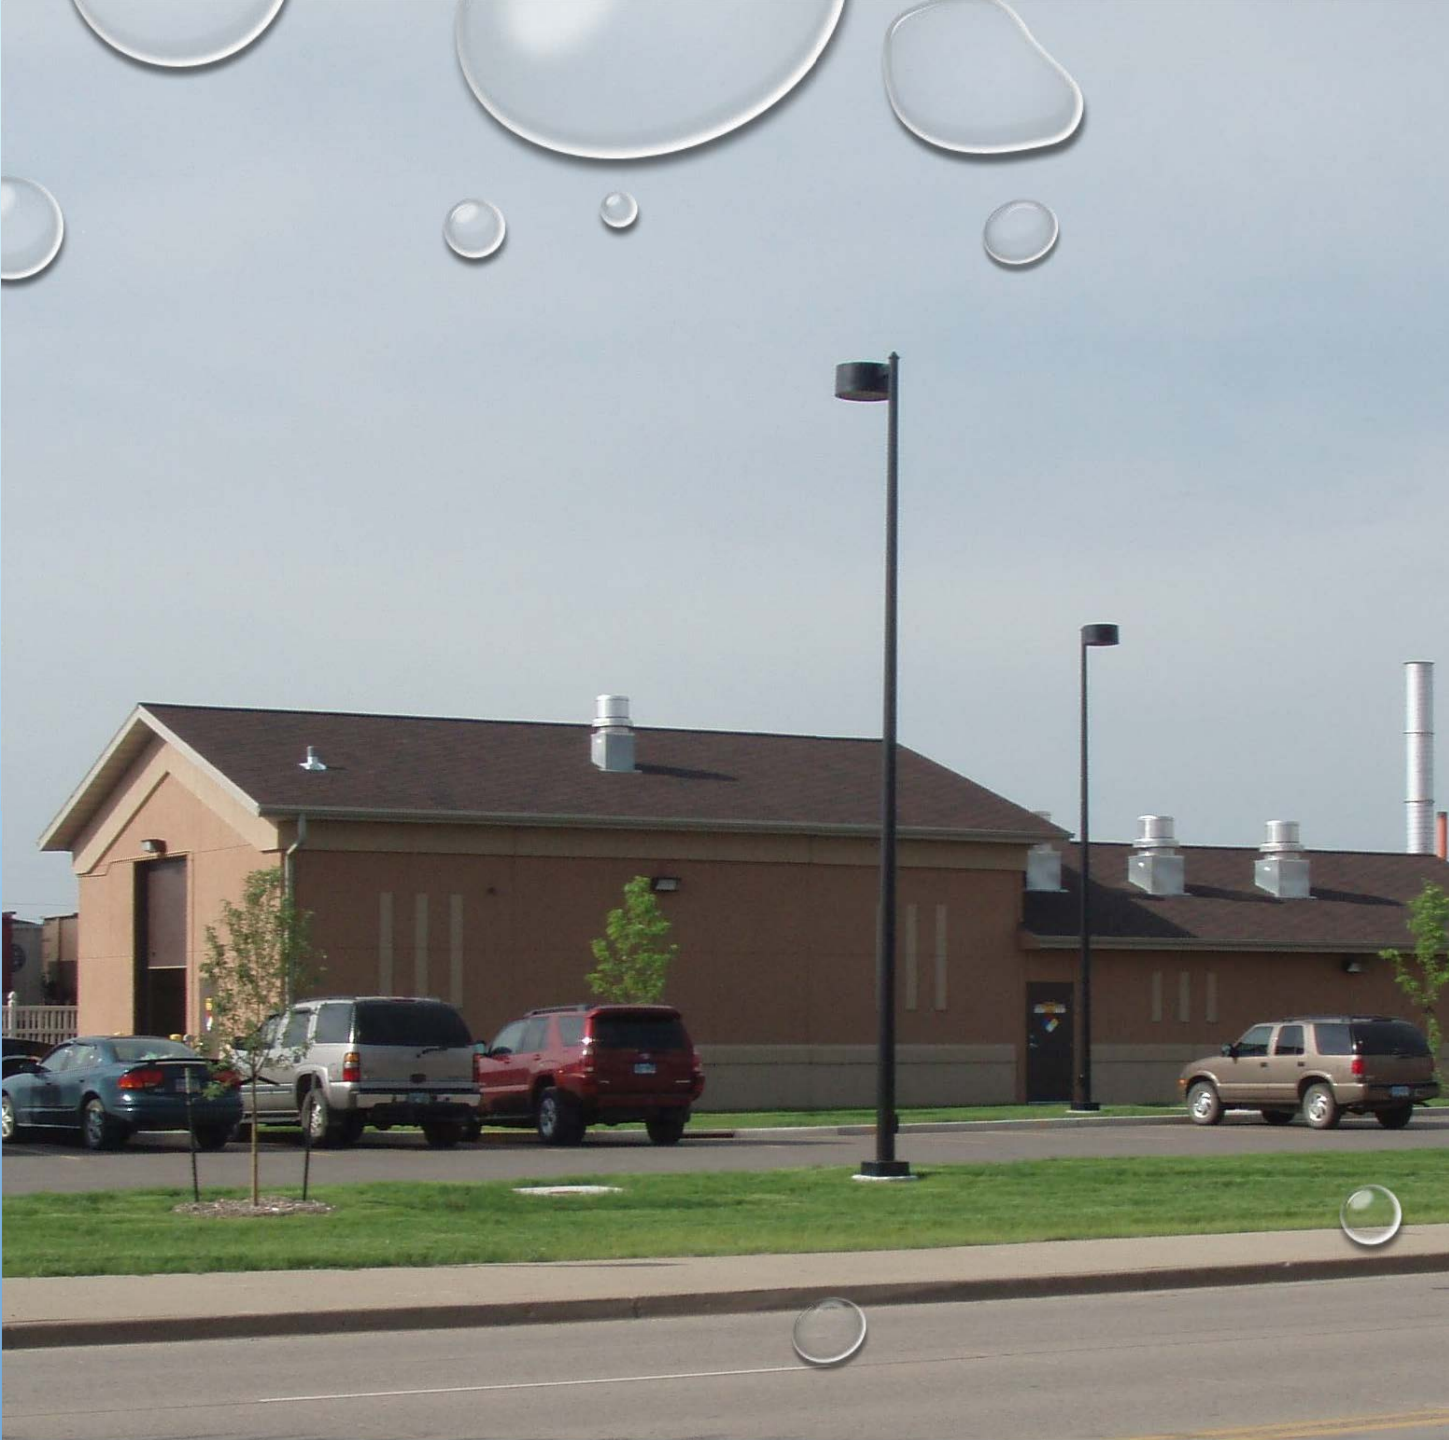
# WASTE WATER TREATMENT SYSTEM SCHEMATIC
